Service Letter No. 405

**SUBJECT:** Inspection of Upper Nose Gear Oleo Bearing

**MODELS AFFECTED:** PA-22 Tri-Pacer, PA-22-108 Colt, PA-22-135, PA-22-150, PA-22-160 Tri-Pacer

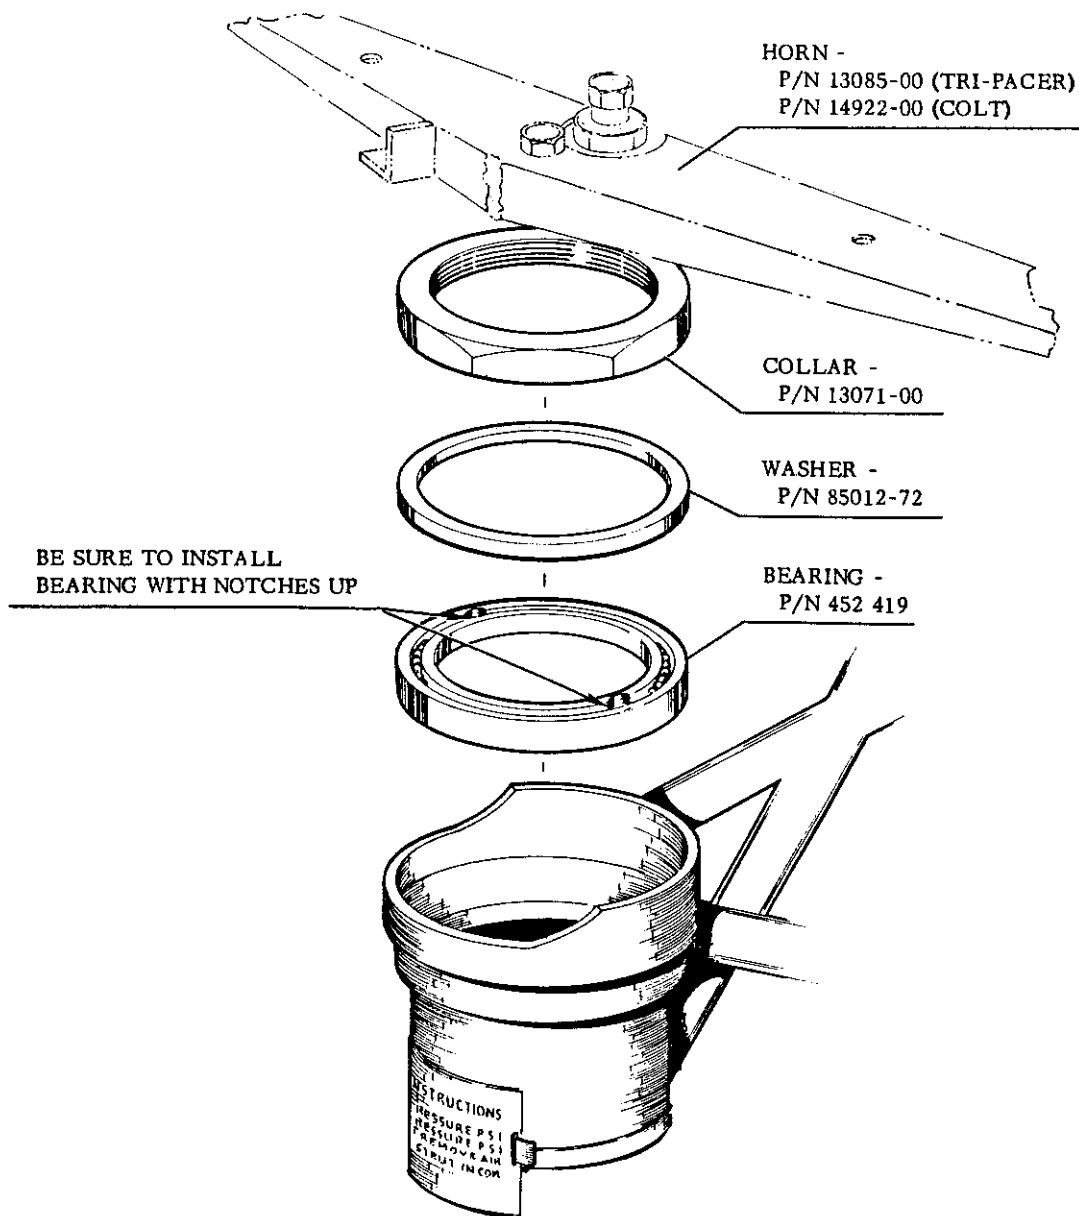
NOTE -

BEARING SHOULD BE LUBRICATED WITH MIL-G-3278 LUBRICANT.
